SH&E at Ground Zero

*A firsthand
account from
the most
dangerous
workplace
in the U.S.*

*By Jeffrey W. Vincoli,
Norman H. Black and
Stewart C. Burkhammer*

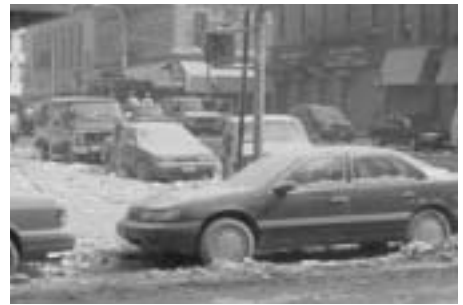
Photo 1 (above): Dust covered everything at and around Ground Zero.

Dust was one of the first things the group noticed. A fine, gray dust, later determined to be mostly pulverized concrete covered everything at the 16-acre disaster site (Table 1). More than 160 buildings in lower Manhattan were cloaked in the powder and would need to be cleaned. Dust was settling everywhere—on the streets, parked vehicles, buildings, lightposts, fences (Photo 1). A tremendous amount of paper was scattered across the site as well—files, notes, pages from desk calendars, photographs, unopened mail,

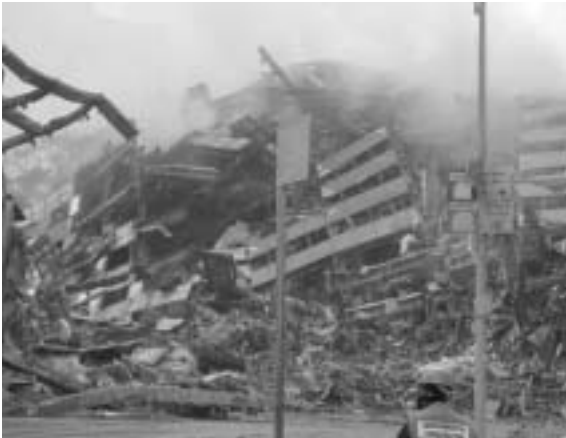
Photo 2 (above, left): WTC-7, a 47-story building destroyed in the attacks.

We first walked past the ruins of WTC Building 7 (Photo 2)—a 47-story office building before it collapsed at 5:20 pm on Sept. 11. We then headed toward the corner of Church and Liberty streets. From here, the full impact of the attack was clear. Where WTC Building 4 once stood laid the remains of Tower 2 (the South Tower, WTC-2), which collapsed at 10:00 am on Sept. 11, raining tons of steel,

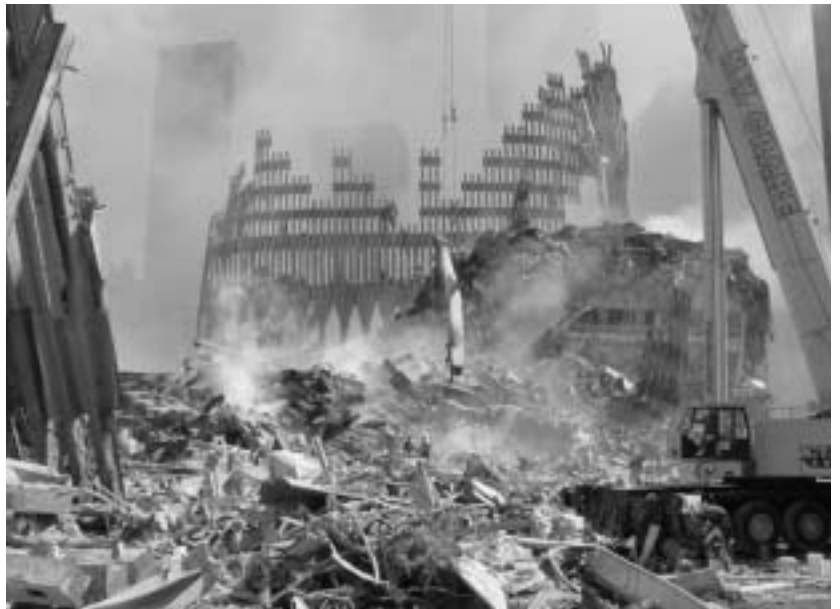
Photo 3 (right): The remains of Tower 2 fell on the southeast corner of WTC-4, which can be seen in the background.

glass and concrete debris onto the southeast corner of Building 4 (Photo 3). All that remained standing of Tower 2 was its lower curtain wall, which was dubbed “the coliseum” because of its odd appearance (Photo 4).

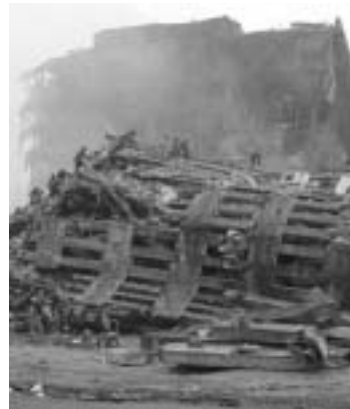
Photo 4 (above, right): The curtain wall of Tower 2, which was referred to as "the coliseum."

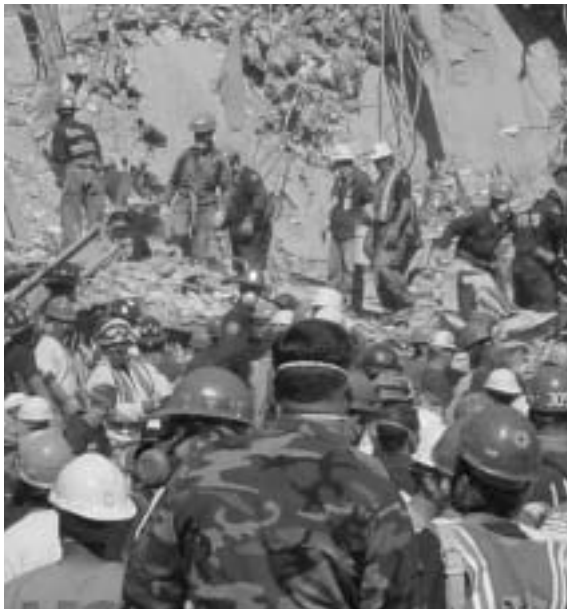
Photo 5 (above): The site was flooded with people trying to assist, many wearing no or improper PPE.

Although the site was extremely dangerous, most volunteers wore no personal protective equipment (PPE). Some wore shorts, sneakers and sleeveless shirts. Others wore some combination/variety of protective equipment—hard hats, dust masks, surgical masks and even handkerchiefs used as respiratory protection. Some wore safety goggles and even faceshields, while others wore no eye protection. This equipment was often inadequate, however. The debris pile was unstable and rife with hazards, including shards of glass, erupting fires, collapsing debris, slippery surfaces, and hundreds of rebar “spears” projecting at all angles from the pile. Heavy equipment (dump trucks, excavators and bulldozers) moved about rapidly, often with no apparent regard for the massive number of pedestrians populating the site. As safety professionals, the scene was an extremely disturbing, even horrifying sight. Little or no control of the work and limited understanding of the hazards set the stage for a serious accident involving one of the rescuers. Thankfully, none occurred.

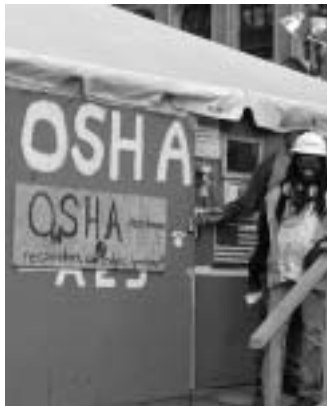
Photo 6 (above, right): One of OSHA's PPE distribution centers and respirator fit test stations near the disaster site.

The Salvation Army, American Red Cross and other groups provided enclosed eating stations and washing facilities for workers. NIOSH, and later OSHA, operated respirator fit testing stations and distributed thousands of respirators to workers (Photo 6). SH&E team members also helped workers with respiratory protection (Photo 7). Triage stations and first-aid facilities were relocated to tents and other protected structures (such as commandeered restaurants, exercise facilities and other establishments located near Ground Zero).

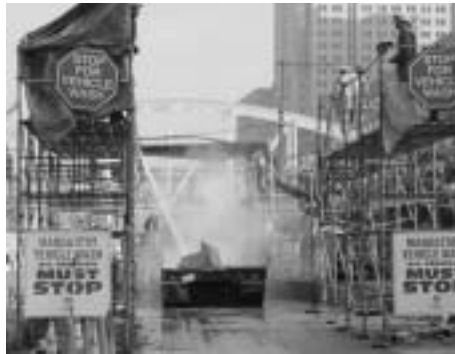
Photo 8 (below): A vehicle wash station at Ground Zero. No vehicles were permitted offsite without first being washed.

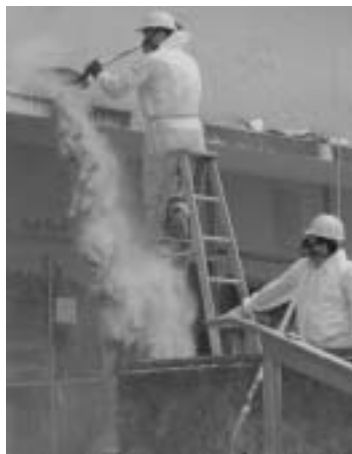
Photo 9 (right): Laborers clean 1 Liberty Plaza. At the time the work was being performed, consistency of the dust was not known.

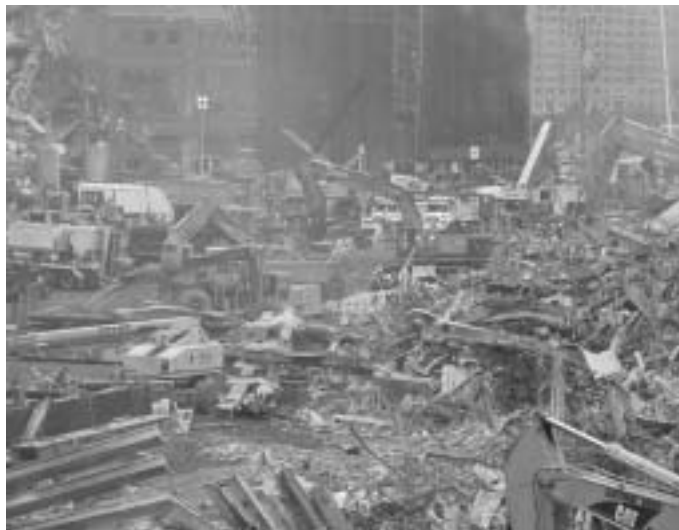
Photo 10 (below, right): A massive amount of heavy equipment was mobilized to assist in the recovery effort. This photo shows only the southwest corner of the 16-acre site.

The tremendous amount of heavy equipment used at Ground Zero created many opportunities for serious accidents (Photo 10). More than 30 crawler cranes (up to 1,000 ton in capacity), several dozen excavators, scores of backhoes and dozers, hundreds of trucks and many other types of equipment moved about the site at a hurried pace

24/7. The team's recommendations to use spotters, back-up alarms, properly caged operator cabs, clear zones and related standard operating procedures prevented several accidents.

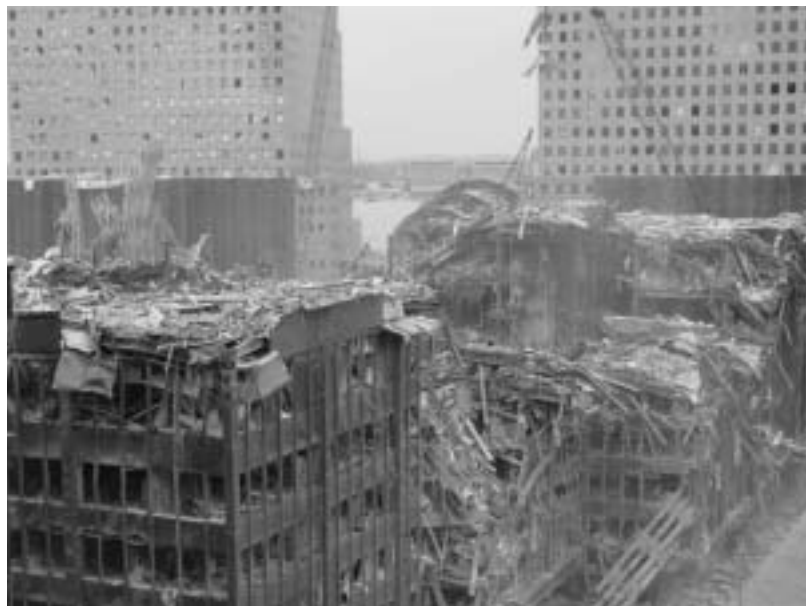
Photo 11 (far left): WTC Building 6 (U.S. Customs) viewed from the roof of a federal building.

- WTC Building 6 housed several federal agencies, primarily U.S. Customs (Photo 11). The third floor—now largely inaccessible—contained a firing range. More than 1.2 million rounds of ammunition were stored on this level, as was a vault used to store other explosives and weapons. A seizure vault was also on the third floor; it contained evidence (such as drugs, cash and evidence files) seized during Customs operations. *Final status: At great personal risk, Customs officials, the FBI and contractor representatives located and removed the criminal evidence from Building 6 during the fourth week of the effort. The ammunition was finally located on Oct. 24, 2001, melted together into large "bullet balls" that were extremely dangerous to handle and dispose of properly (Photo 12). At one point, a discharge of a bullet, due to the immense heat in the area, caused a shrapnel wound to the face of one worker.*

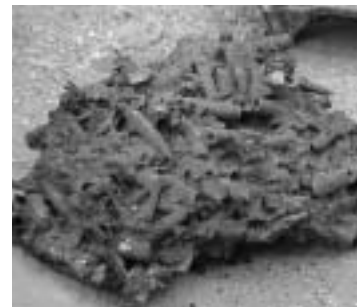
Photo 12 (top): A bullet ball located near WTC-6, which housed a firing range. More than 1 million pounds of ammunition were lost.

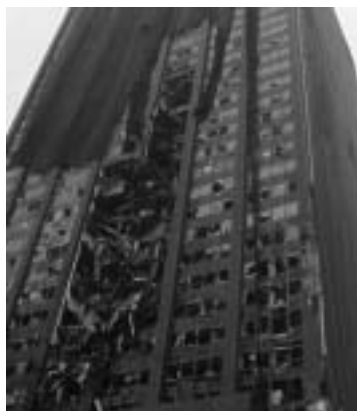
Photo 14 (top): The north face of 130 Liberty St. The broken windows were eventually covered completely with protective, flame-retardant netting.

•Glass from the many thousands of windows in the still-standing buildings that surrounded Ground Zero was broken; with the slightest wind or vibration, it showered down onto the rescue site. Because it took days for these buildings to be properly draped with protective netting (many stood more than 50 stories high), personnel faced a constant threat when working near these buildings (Photo 14).
